PHASE IA ARCHEOLOGICAL INVESTIGATION

Manchester RAISE Grant Project

City of Manchester
Hillsborough County, New Hampshire

February 2023

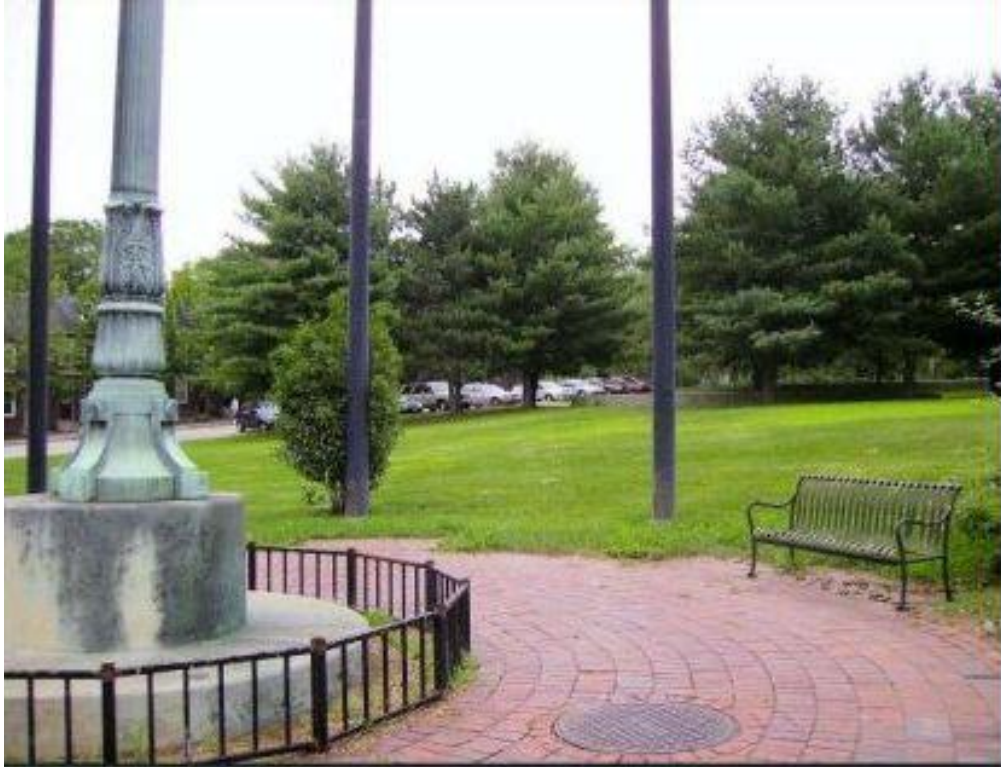
Figure 1. The Gateway Park historic lamp on its original pedestal. Photographer unknown. View facing northeast.

pedestal with a brick path along its perimeter (see Figure 1). This pedestal was removed during the expansion of the adjacent streets and the lamp was moved to its present location. The eastern area of the park is occupied by a large, raised concrete circle that is identified as a playground on engineer plans (Photo 19). The northern circumference of the circle connects to the adjacent parking lot via a paved path. This parking lot serves several brick residential structures in the immediate area.

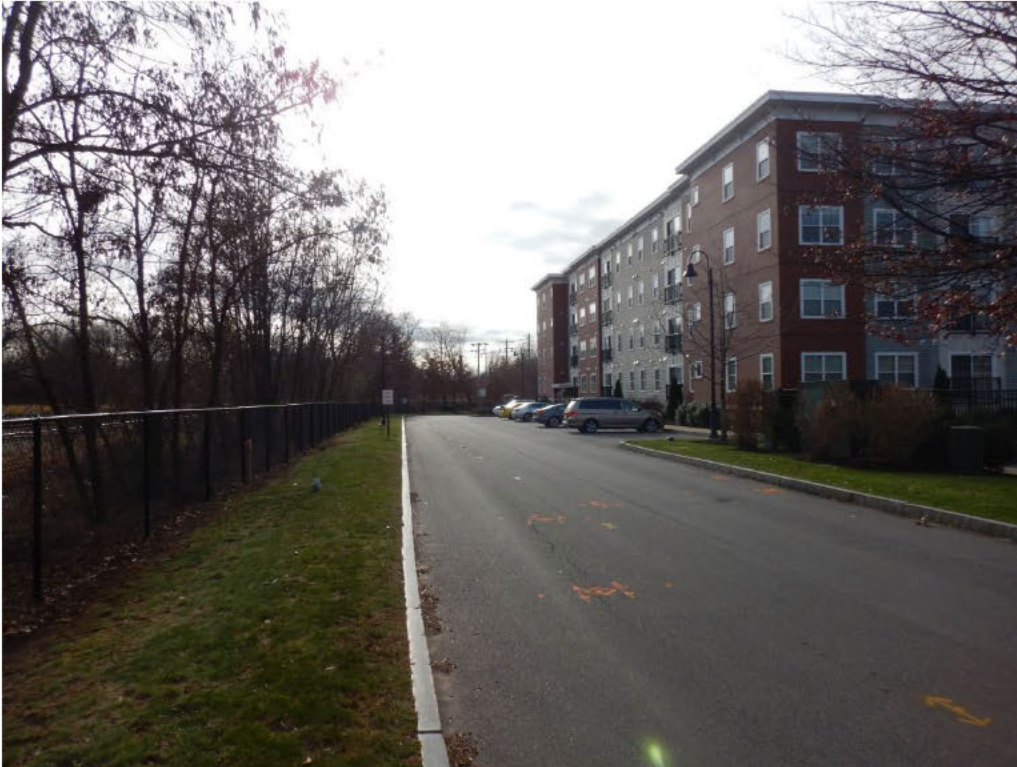
Photo 1. Riverwalk Way in the Component A APE. Note the chain link fence (left) separating the railroad from the road and the multistory apartment building (right). View facing southwest.

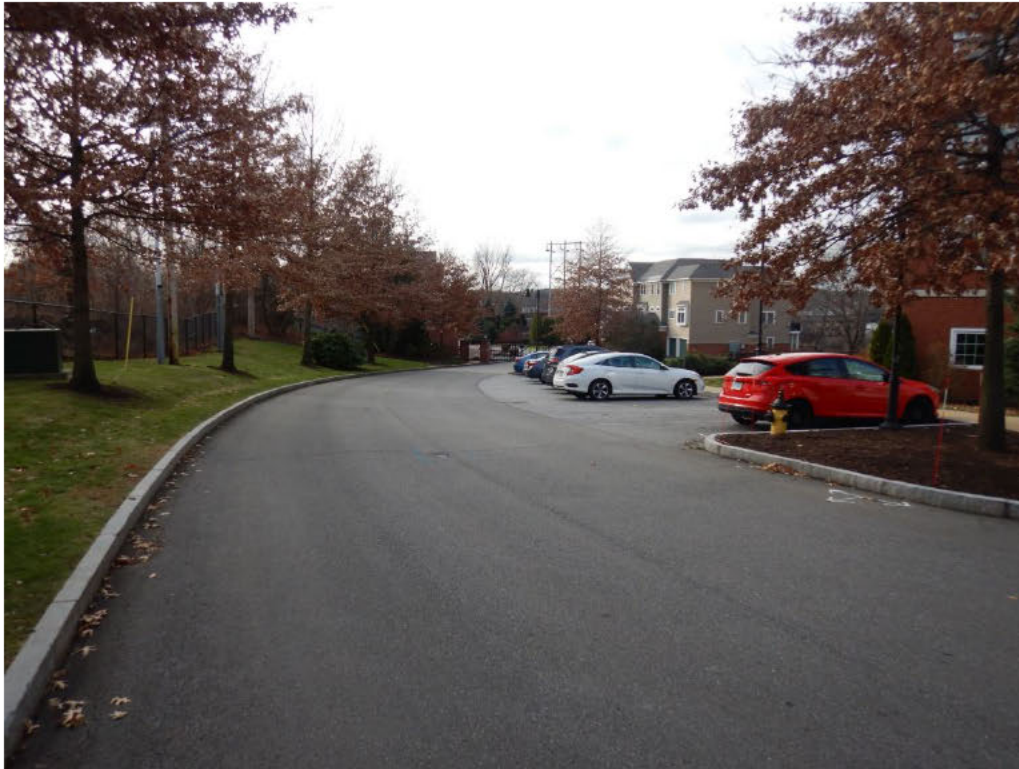
Photo 2. The curved portion of Riverwalk Way. Note the landscaping with deciduous trees, utility box, and electric poles (upper left). Also note the slope of the ground on the shoulder compared to the road's level path, indicating that the landscape was graded to create the road. View facing southwest.

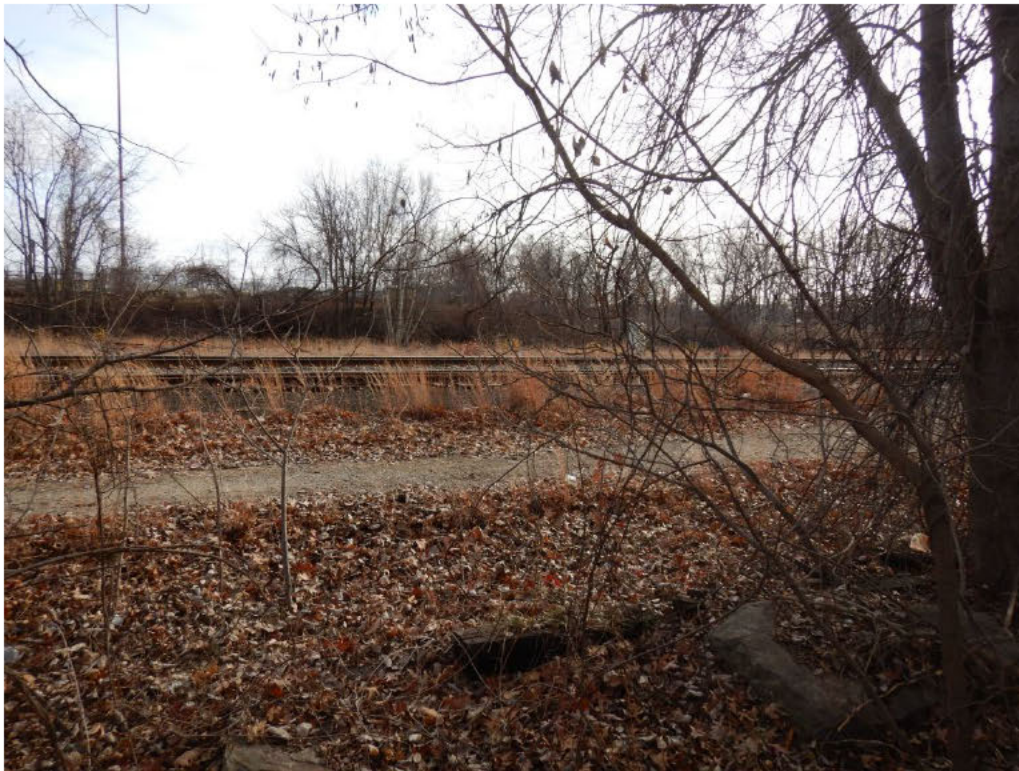
Photo 3. View of the Component A railroad section that separates Riverwalk Way and Gas Street. View facing southeast.

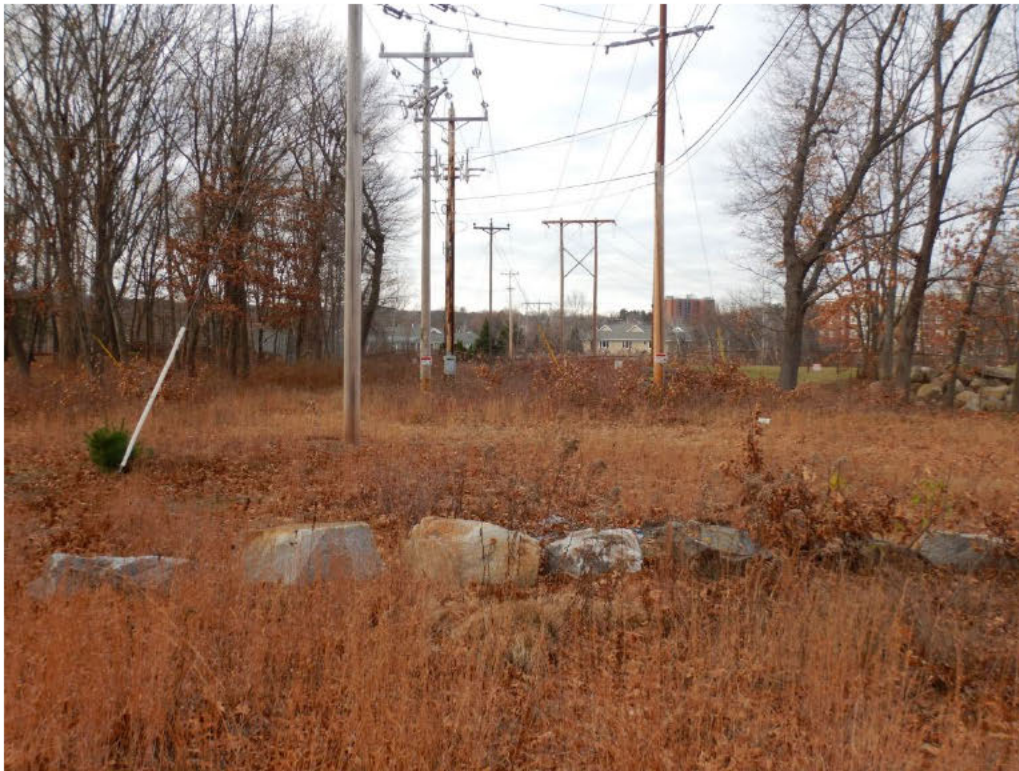
Photo 4. View the clearing connecting Gas Street to the railroad segment depicted in Photo 3. View facing northwest.

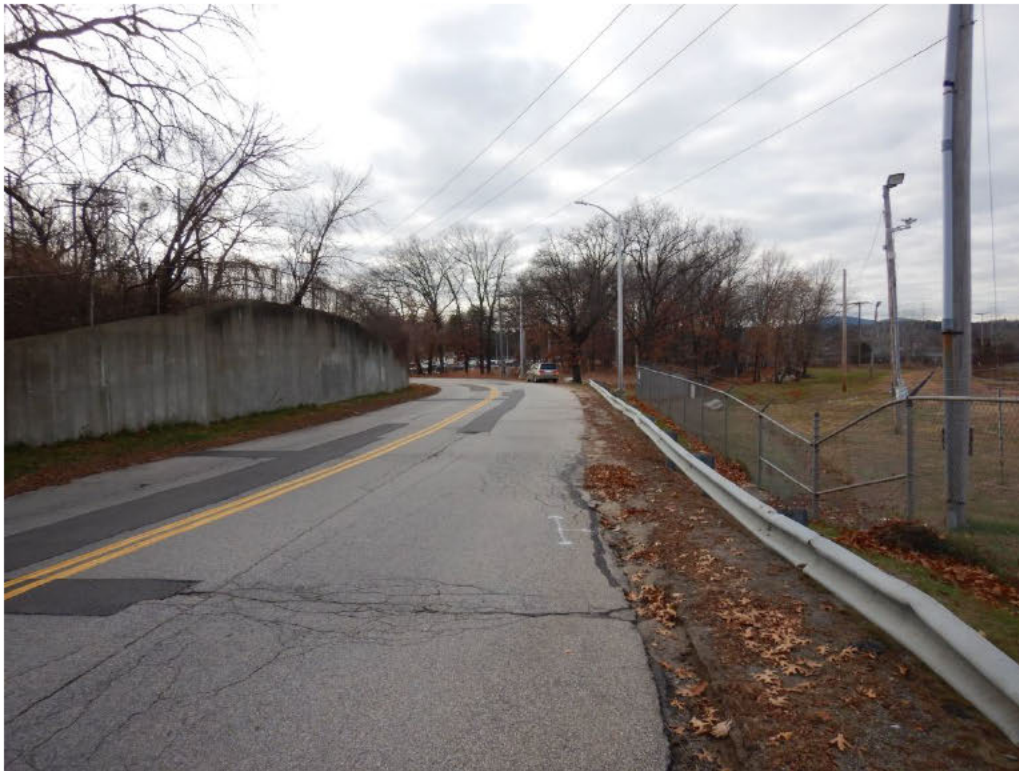
Photo 5. View of Gas Street. Note the large concrete retaining wall (left) which shows that a substantial area of the hillside was removed when Gas Street was built. View facing west-southwest.

Component A: historic maps indicate the majority of the APE was either railyard or undeveloped into the 1950s. Additionally, the Riverwalk Development Project, Phase IA/IB report of adjacent areas determined that the area has been subject to fill and disturbance that would have compromised any archeological resources in the area (see Table 4). No further work is recommended for the APE area west of the railroad along Riverwalk Way. Archeological investigations are recommended for any planned subsurface disturbance in the undeveloped areas of the APE between Gas Street and the extant railroad to the northwest (see Map 2a for archeologically sensitive areas). The field supervisor should adjust shovel test locations as needed to avoid areas of disturbance created by the drainage swale in the southeast archeologically sensitive area. Testing should avoid known locations of subsurface disturbance created by buried utilities. No further work is recommended for the southern region of Gas Street where retaining walls indicate significant grading and disturbance of the immediate area.

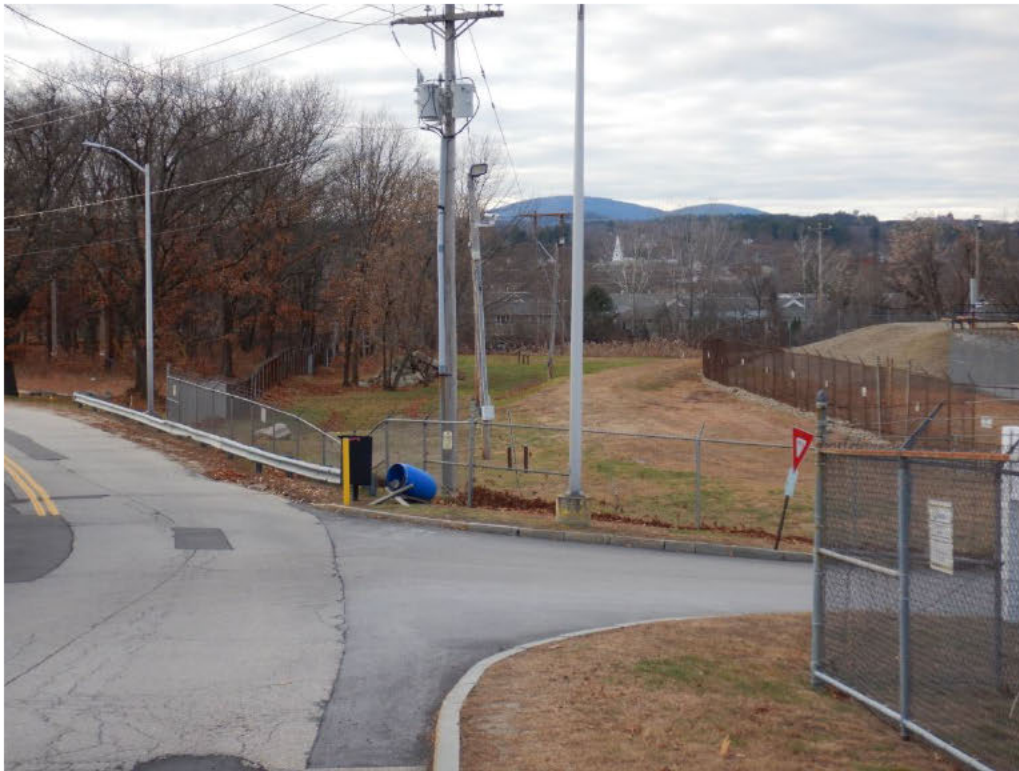
Photo 6. View of the grass area adjacent to the area of Gas Street shown in Photo 5. Note the raised remnants of a railroad bed directly outside the chain link fence (middle right). A pipe and cobbles for drainage swale run underneath the road connecting to Gas Street. The westward extent could not be determined due to the inability to access the area. View facing west.

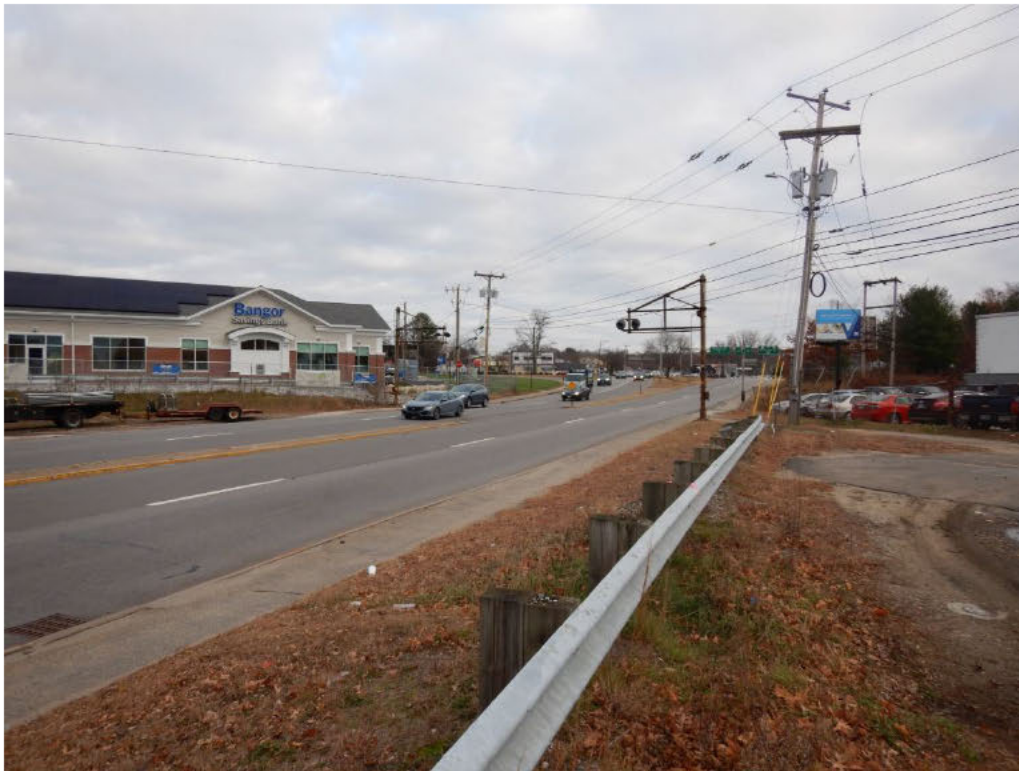
Photo 7. View of Queen City Avenue. Note the sidewalk and vehicle guardrail (center foreground), indicating likely disturbance beyond the road itself. Also, note the derelict railroad signal (left of electric pole, middle ground center right), a remnant of the Manchester and Lawrence Railroad that once bisected this area. Both ends of this railroad bed can be seen in Photos 8 and 13. View facing northeast.

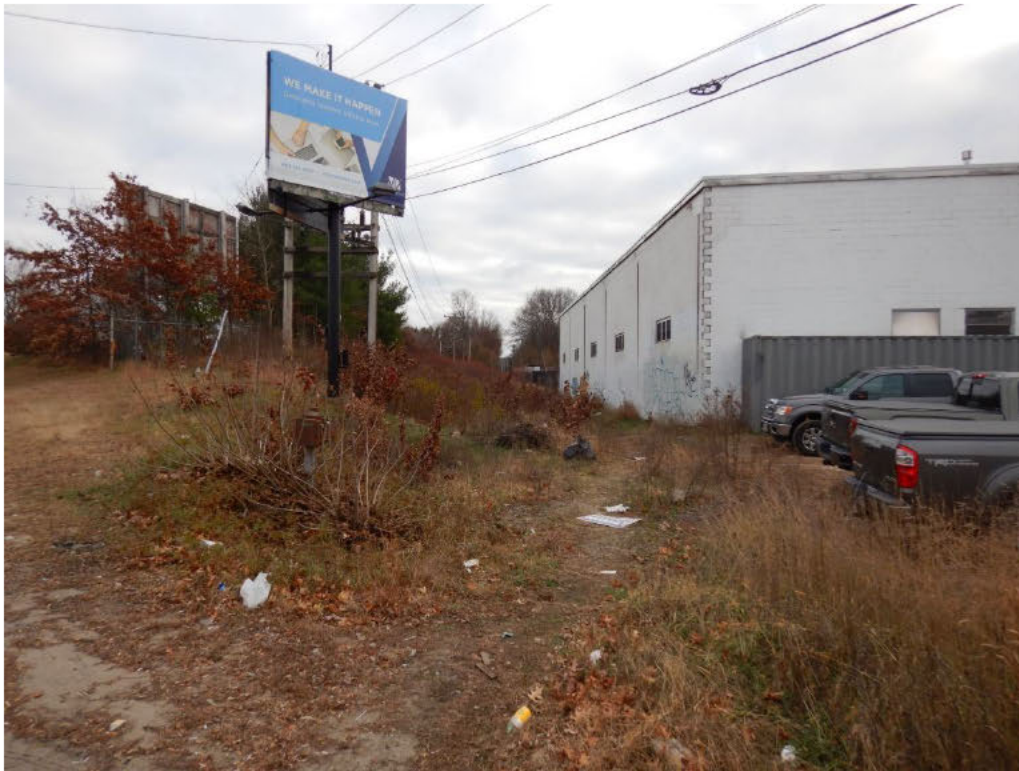
Photo 8. View of part of the railroad bed remnants that bisected Queen City Avenue. Note the slope of the ground to the left of the white structure, indicating that the flat area immediately behind the building was likely altered to create a level grade for the Manchester and Lawrence Railroad. View facing southeast.

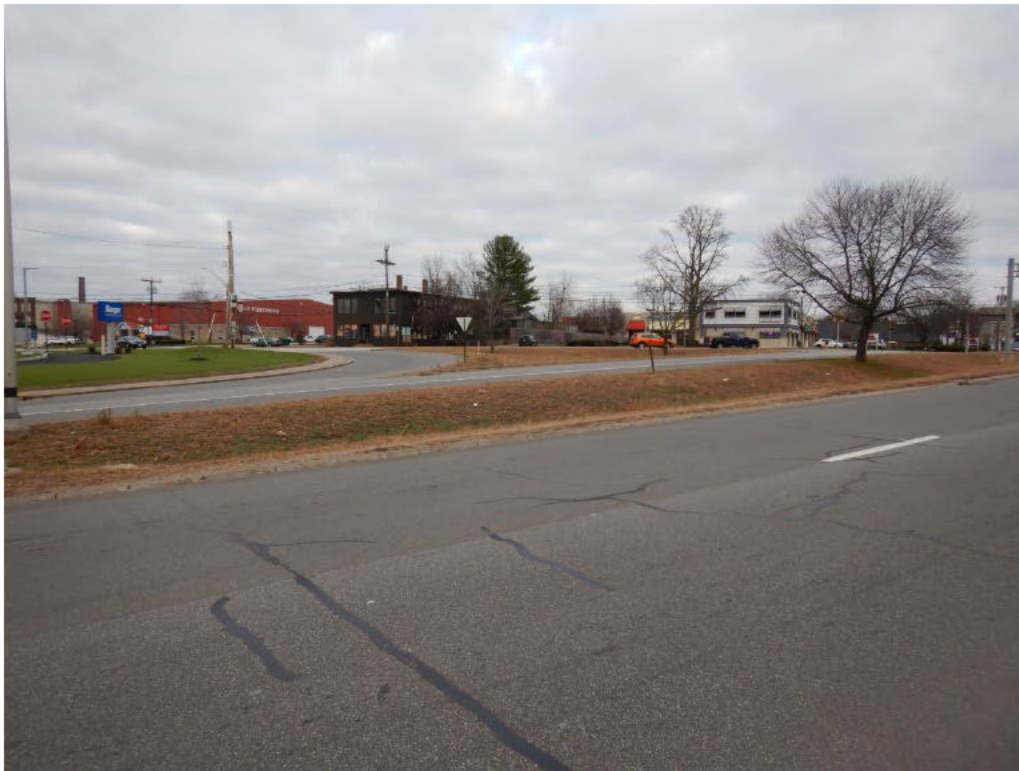
Photo 9. View of the center of the Queen City Avenue intersection. View facing northeast.

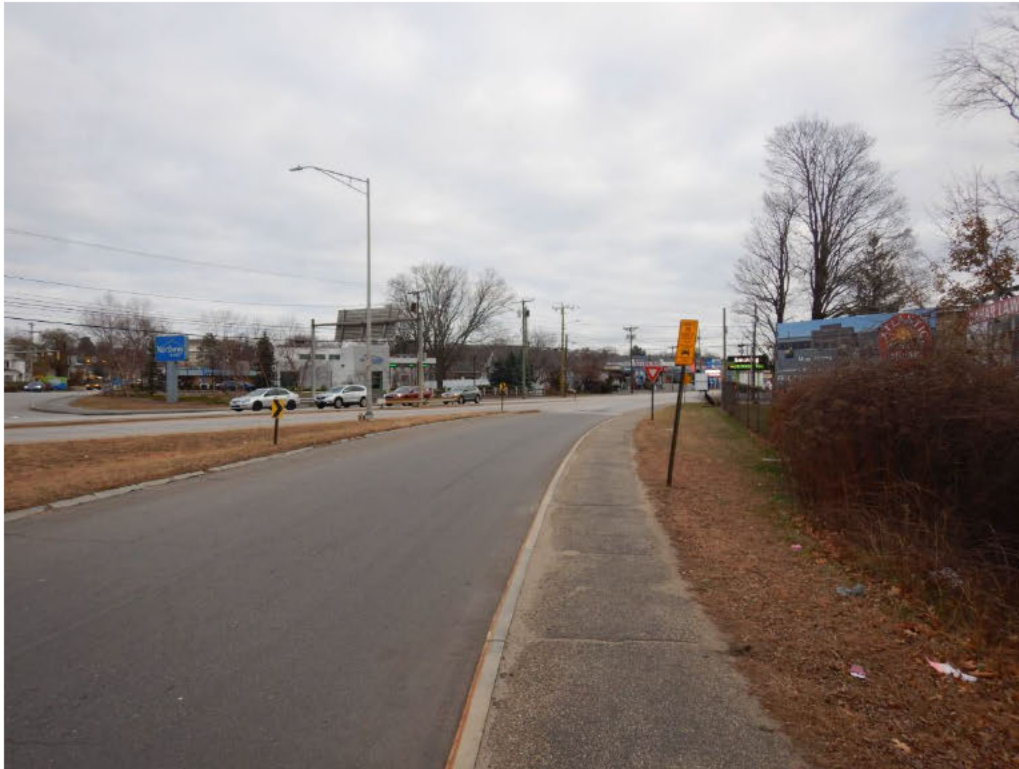
Photo 10. View of the southern area of the intersection. Note the streetlights on the grassy island (middle ground center), sidewalk, and chain link fence (right). View facing southeast.

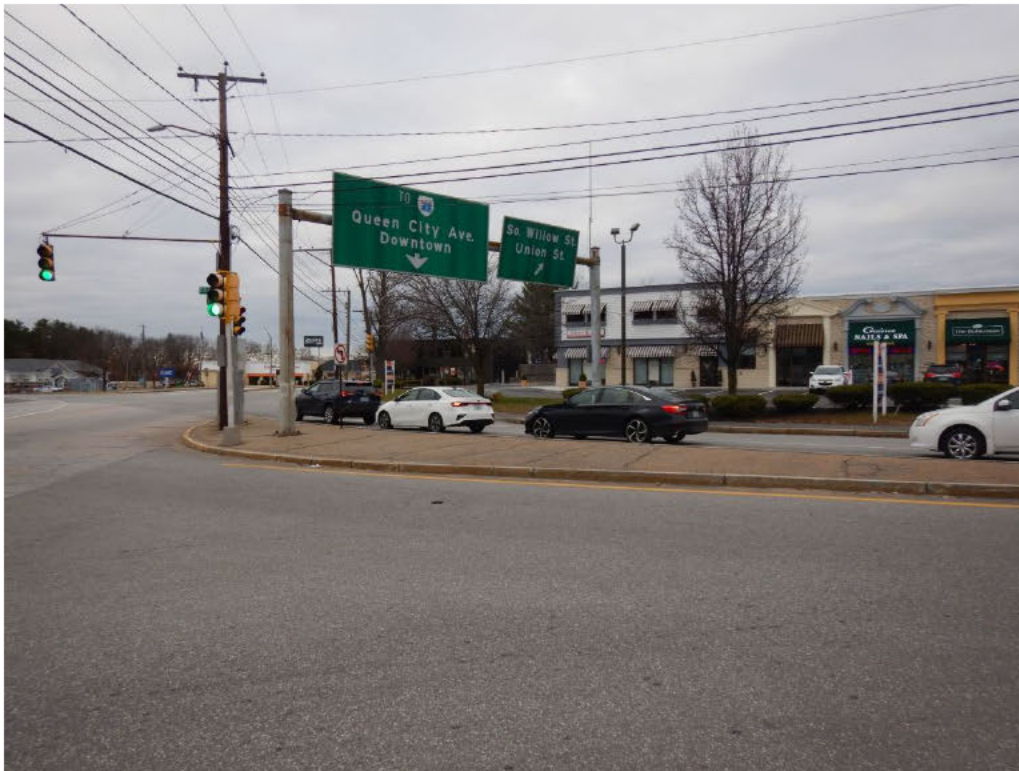
Photo 11. View towards the northern area of the APE. Note the lack of a grass island in this area, indicating that the natural soil level may have been completely removed when the present intersection was constructed. View facing northwest.

Component B: No further work is recommended due to extensive paving and evidence of subsurface disturbance from buried utility lines.

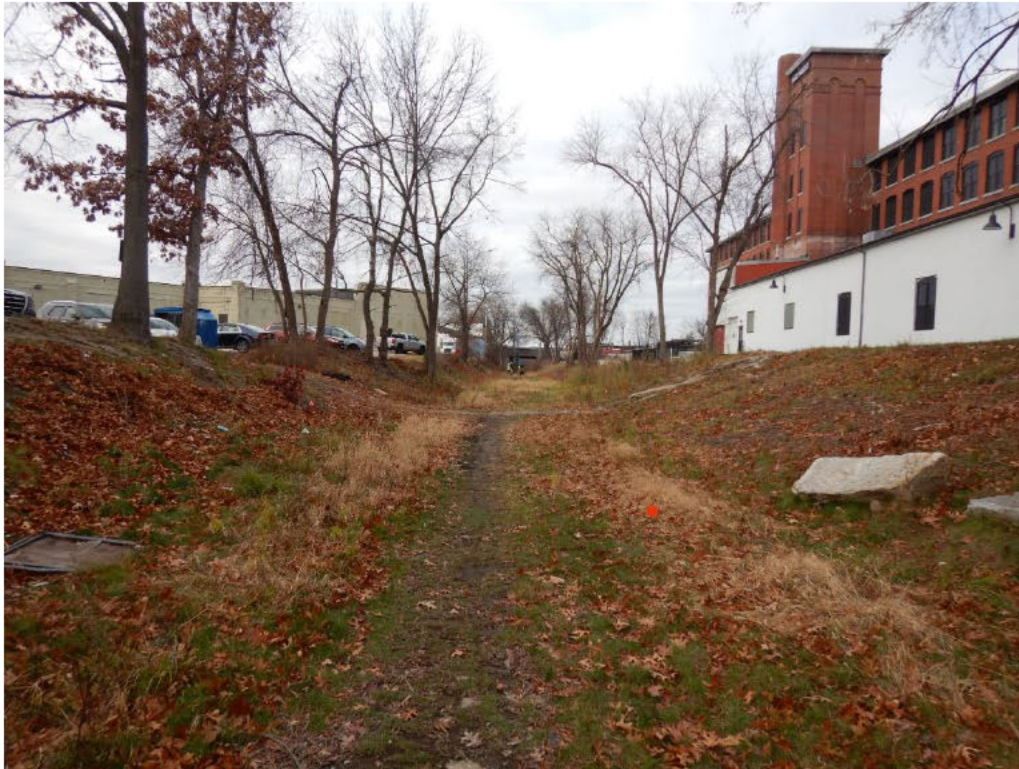
Photo 12. View of the abandoned railroad bed running behind the Cohas Shoe Factory building (right). Note the slope of the ground on either side, indicating that the ground was lowered to create a level surface for the railbed. View facing northwest.

Component C: Archeological investigations are recommended for the APE section immediately behind the historic Cohas Shoe Factory due to the possibility of finding archeological remains associated with the industrial use of the building and activities related to loading/unloading cars on the adjacent railroad. Archeological testing is also recommended in the southern area of the APE due to the Sanborn map documented structures associated with the railroad in the immediate vicinity (see Map 3c). Archeological monitoring is recommended for the APE section that extends along the access road connecting the former railbed to the present parking lot due to the possible presence of map-documented outbuildings and railroad siding platform associated with the Cohas Shoe Factory (see Map 2c for sensitive archeological areas).

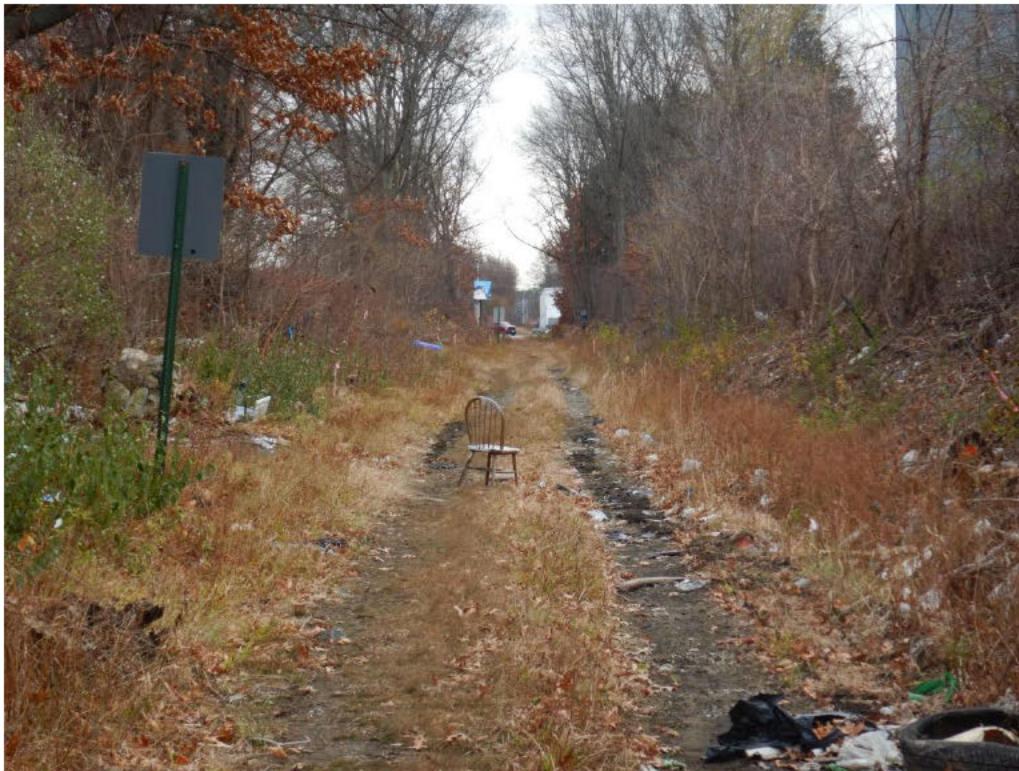
Photo 13. View of the southern area of the Component C APE. Note the billboard and cars along Queen City Avenue (Component B APE) in the background. This area of the Component B APE can be seen in Photos 7 and 8. Also note the wheel ruts and extensive refuse (foreground) reflecting more extensive use of this area compared to the APE section shown in Photo 12 which lacks as pronounced wheel ruts and extensive refuse. View facing southeast.

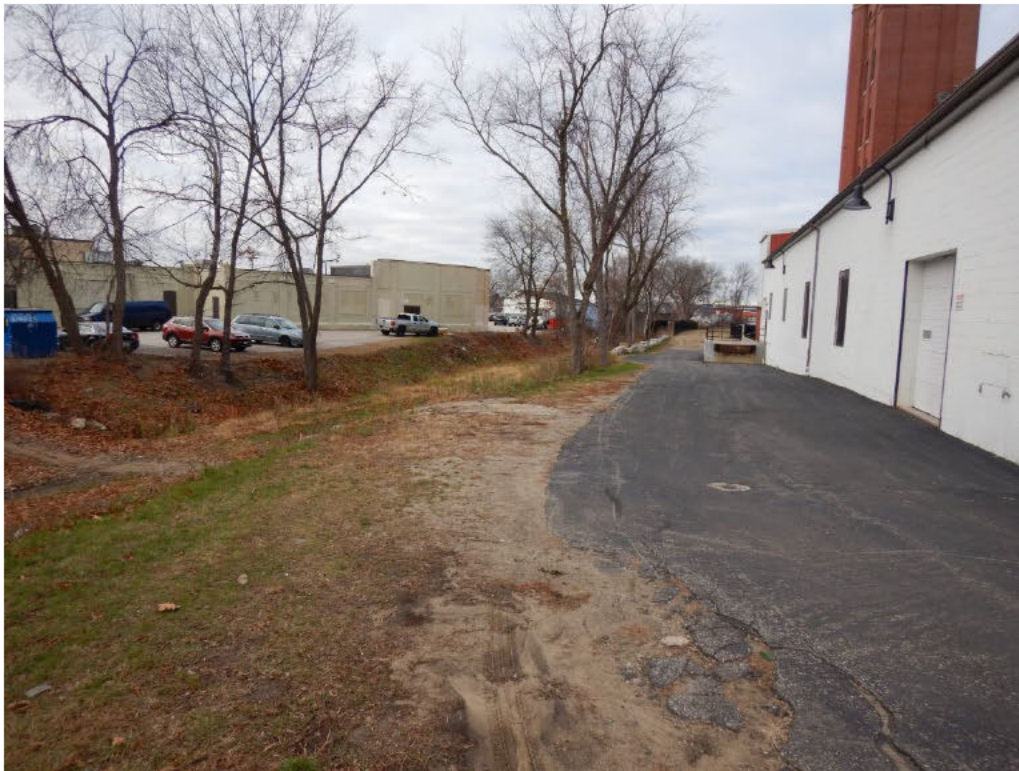
Photo 14. View of the railbed from the ground level of the Cohas Shoe Factory. Note the pronounced steep slopes down to the railbed. View facing northwest.

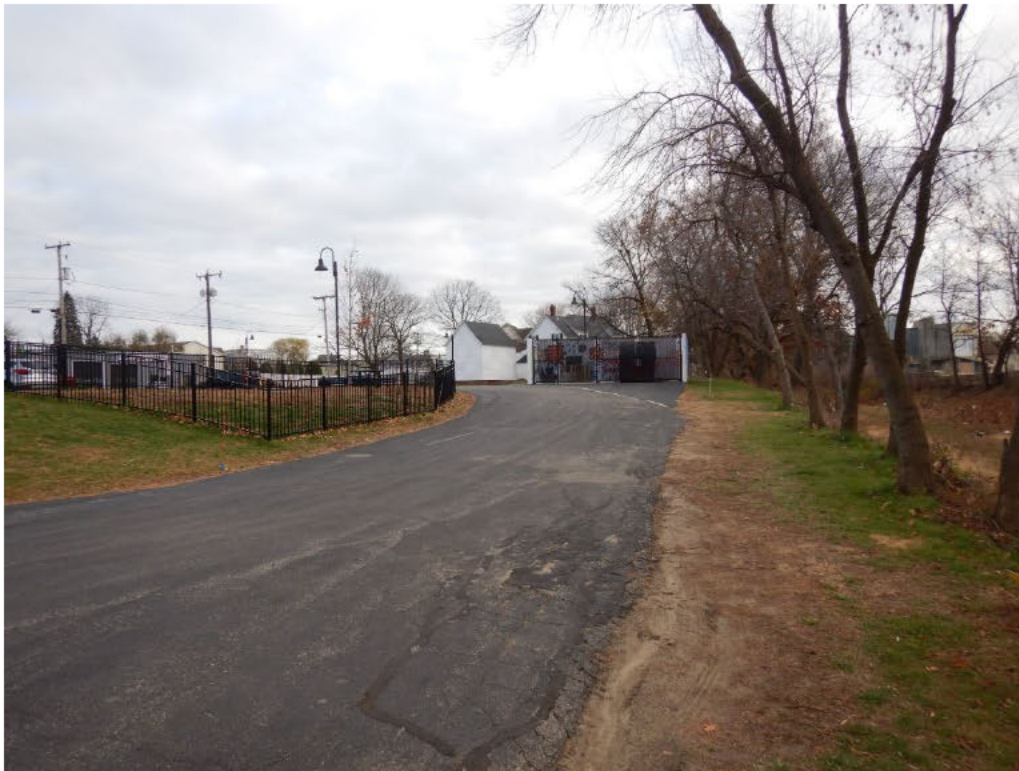
Photo 15. View of the access road connecting the rear of the Cohas Shoe Factory (Photo 14) to the adjacent parking lot. Historic maps indicate that smaller buildings associated with the factory may have been located in this general area. View facing southeast.

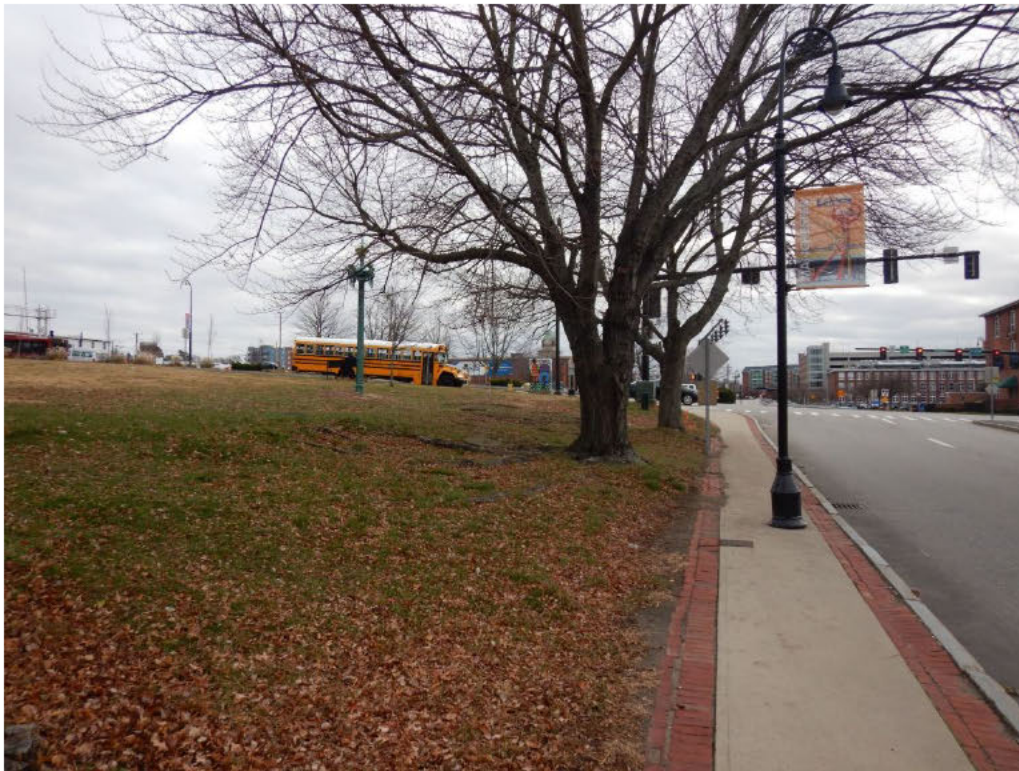
Photo 16. View of the Component D APE. Note the sidewalk which runs along the western and southern perimeter. Also note the park lamp (center-left middle ground in front of the school bus; lamp also shown in Photo 17). View facing south-southeast.

Component D: Most of the Amoskeag Mill worker tenement buildings appear intact. The 1897 Sanborn indicates that an additional row of tenement buildings was in the present location of Gateway Park (see Map 3d). Archeological investigations at similar company housing, such as at Boott Mills in Lowell, Massachusetts, have uncovered evidence of the individuality and daily lives of the factory workers who once lived there (Mrozowski, et al. 1996). Due to the potential for archeological deposits to yield information on the lives of the Amoskeag Mill workers, archeological testing is recommended for subsurface disturbances planned in areas of Gateway Park not already disturbed by existing utility lines. Due to the Sanborn map documented presence of storehouses associated with the Amoskeag Mill complex in the southern APE area, site monitoring is recommended for subsurface disturbances greater than three feet in depth (1 meter). Site monitoring should focus on identifying intact foundation remains and other features associated with these maps documented storehouse buildings.

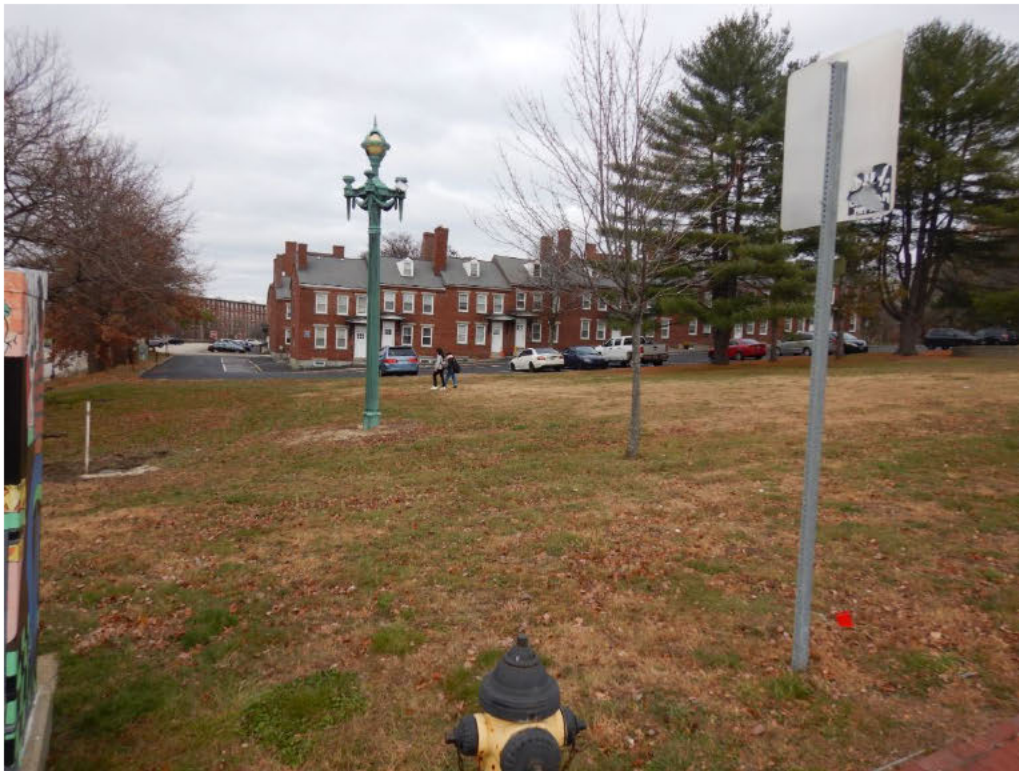
Photo 17. View of the southwest corner of the APE. Note the fire hydrant and utility box (foreground). Also note the lamp (center left) and brick tenement buildings to house workers at the Amoskeag Manufacturing Company. The lamp once lit the Queen City Bridge and was relocated to the park to commemorate the historic lighting styles of the city. View facing northwest.

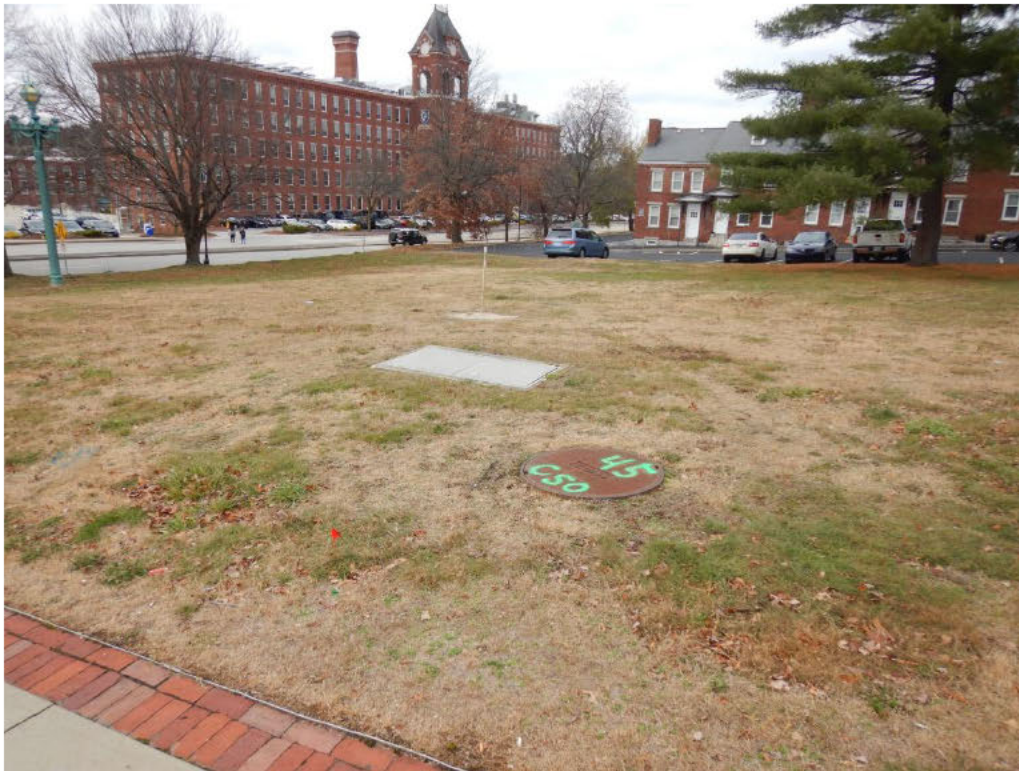
Photo 18. Additional view of the southern APE area. Note the utility hole covers indicating some subsurface disturbance in the immediate area. Also note the repurposed Amoskeag Manufacturing Company building (top left) and tenement buildings (top right). View facing northwest.

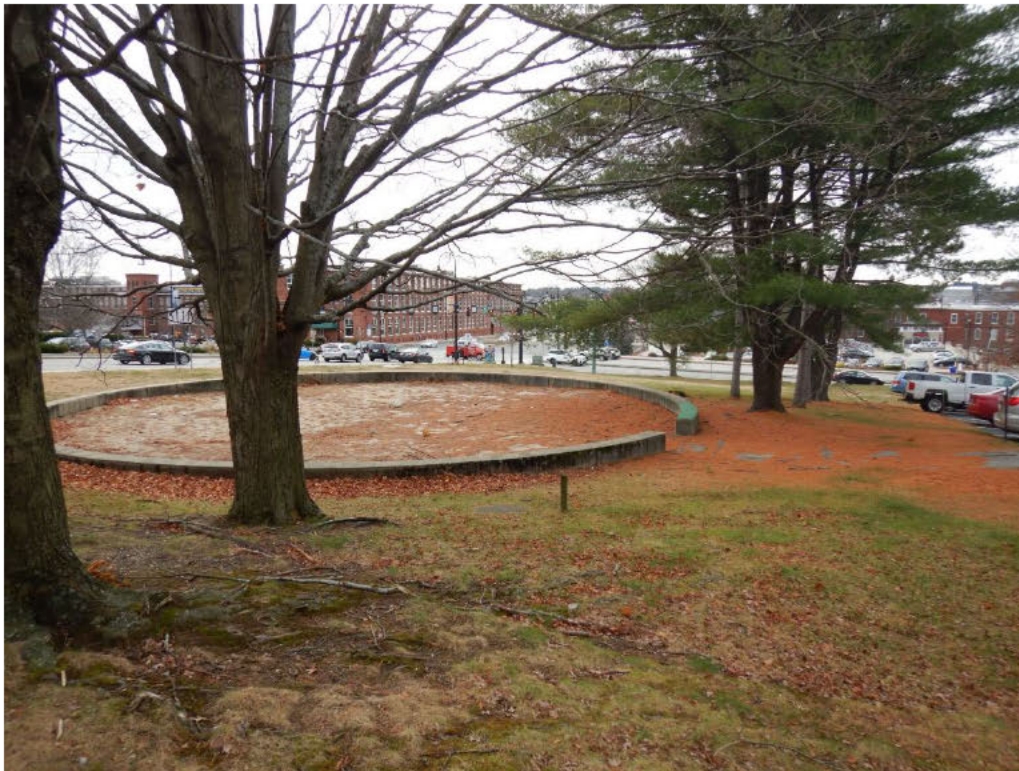
Photo 19. The large concrete circle at the eastern end of the park. Note the walking path (covered by orange leaves/pine needles) that connects to the adjacent parking lot. Also, note the brick industrial building (background center left), which reflects how extensive the Amoskeag Manufacturing Company complex was. View facing west.

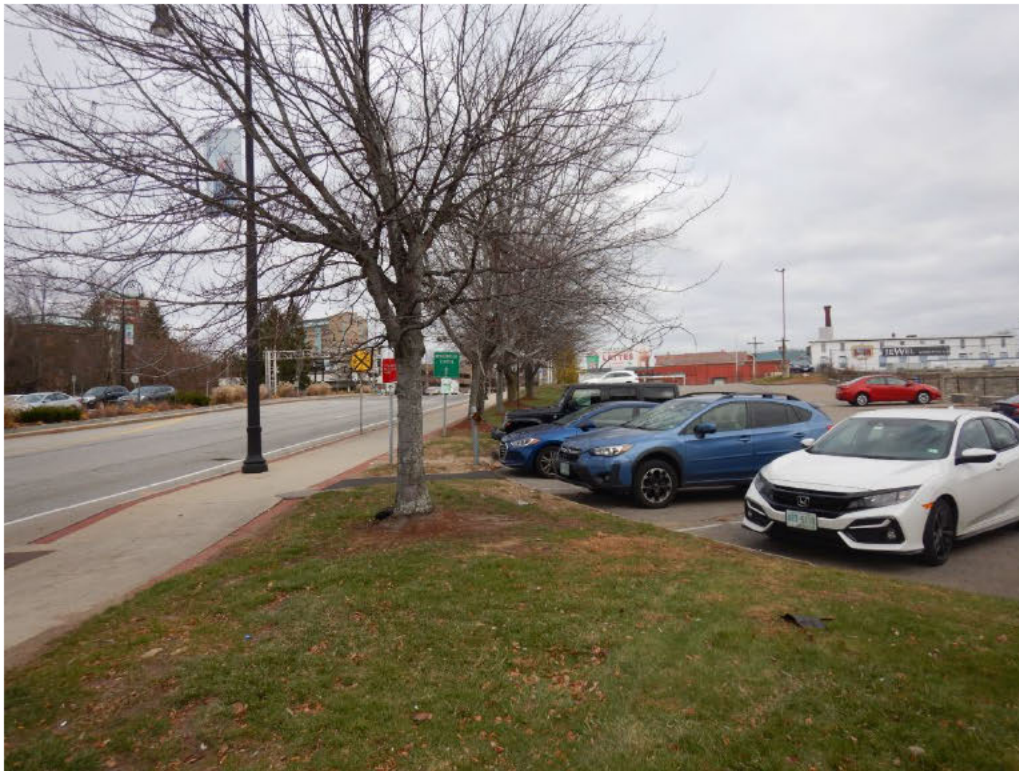
Photo 20. View of the southern portion of the Component D APE looking east along Granite Street. Note how the parking lot follows the slope of the adjacent road.

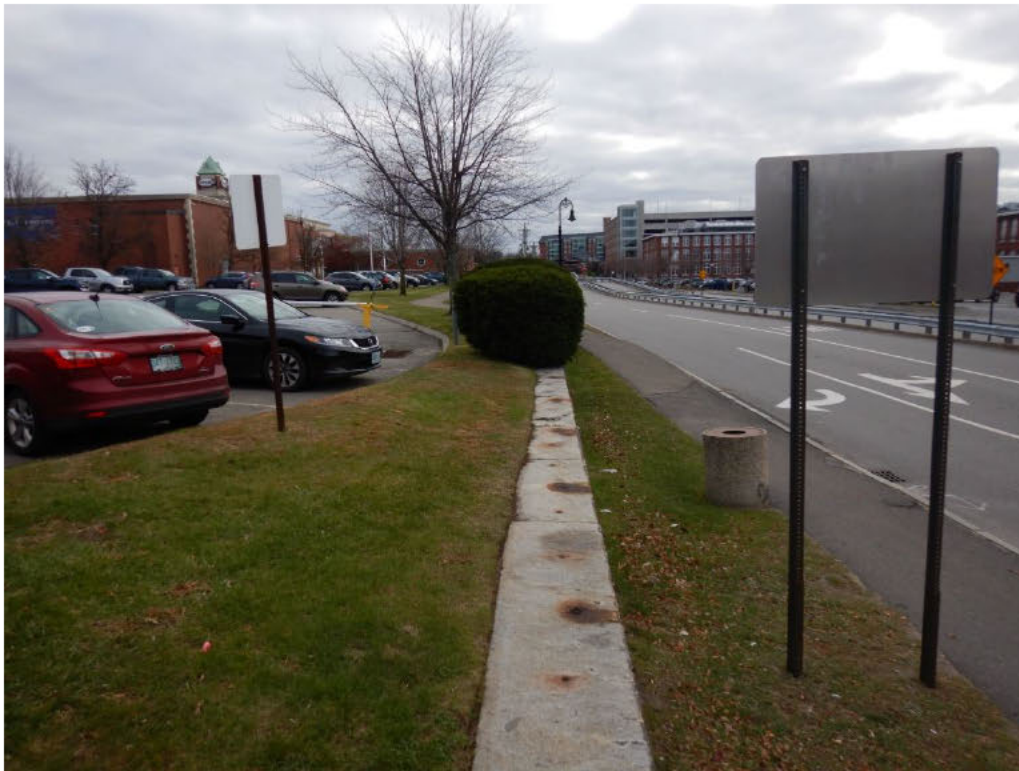
Photo 21. View of the southern area of Component D APE looking south along South Commercial Street. Note the low retaining wall (center) which indicates that the sidewalk and road are below the natural grade. View facing southeast.

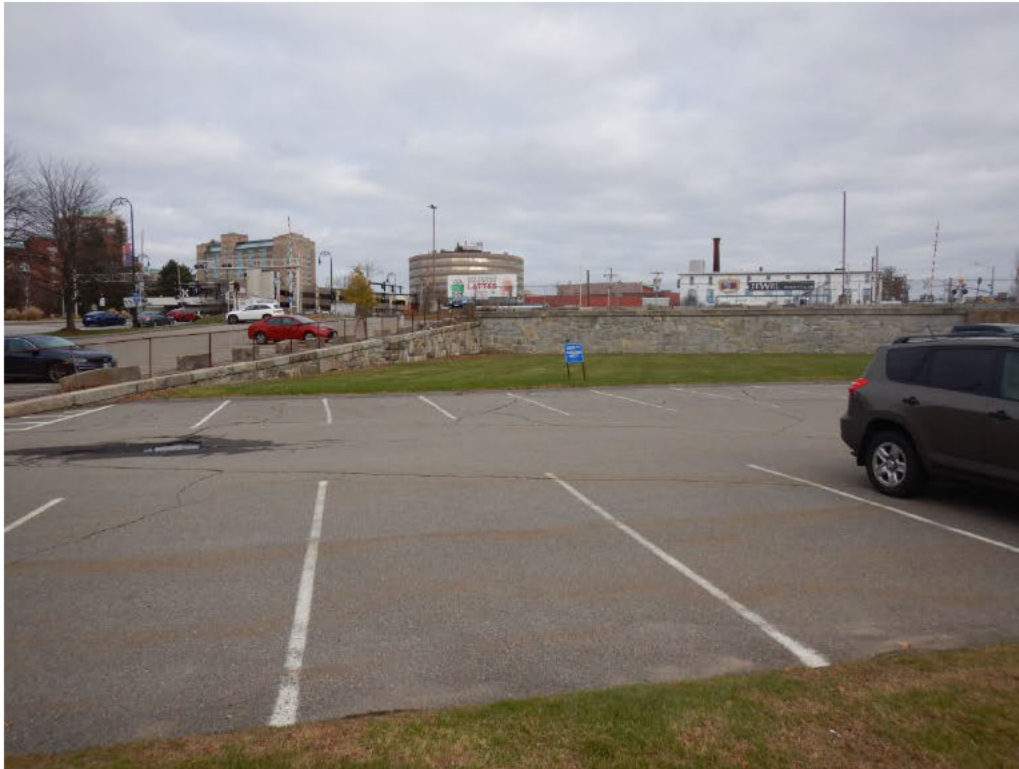
Photo 22. View of the parking lot and central area of the southern section of the Component D APE. The large stone retaining wall indicates that the grassy area in the middle of the triangle was significantly lowered and graded from the terrain's natural slope. View facing northeast.
